# Fire on board *BBC Rhonetal*

Port Hedland, Western Australia on 25 March 2021

## **ATSB Transport Safety Report**

MO-2021-002

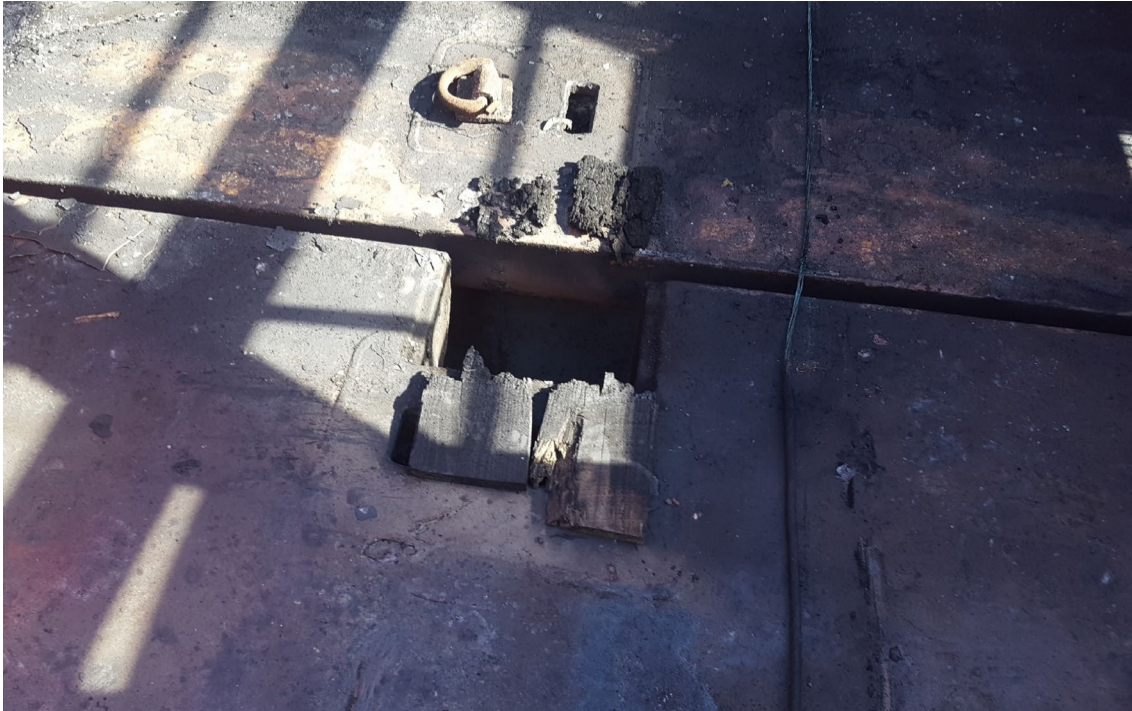
**Figure 2: Tween deck gaps**

The firefighting equipment included three fire hoses which were pressurised (using the ship's fire main line) and ready for immediate use by opening their fire nozzles. There were also two fire extinguishers, two spark arrester drums and four fire blankets close by. The fire blankets each measured about 2 m in length and were to be used to cover the gaps in the tween deck (Figure 2)

near the work areas to prevent sparks and molten metal produced by the cutting work from falling through to the lower hold.

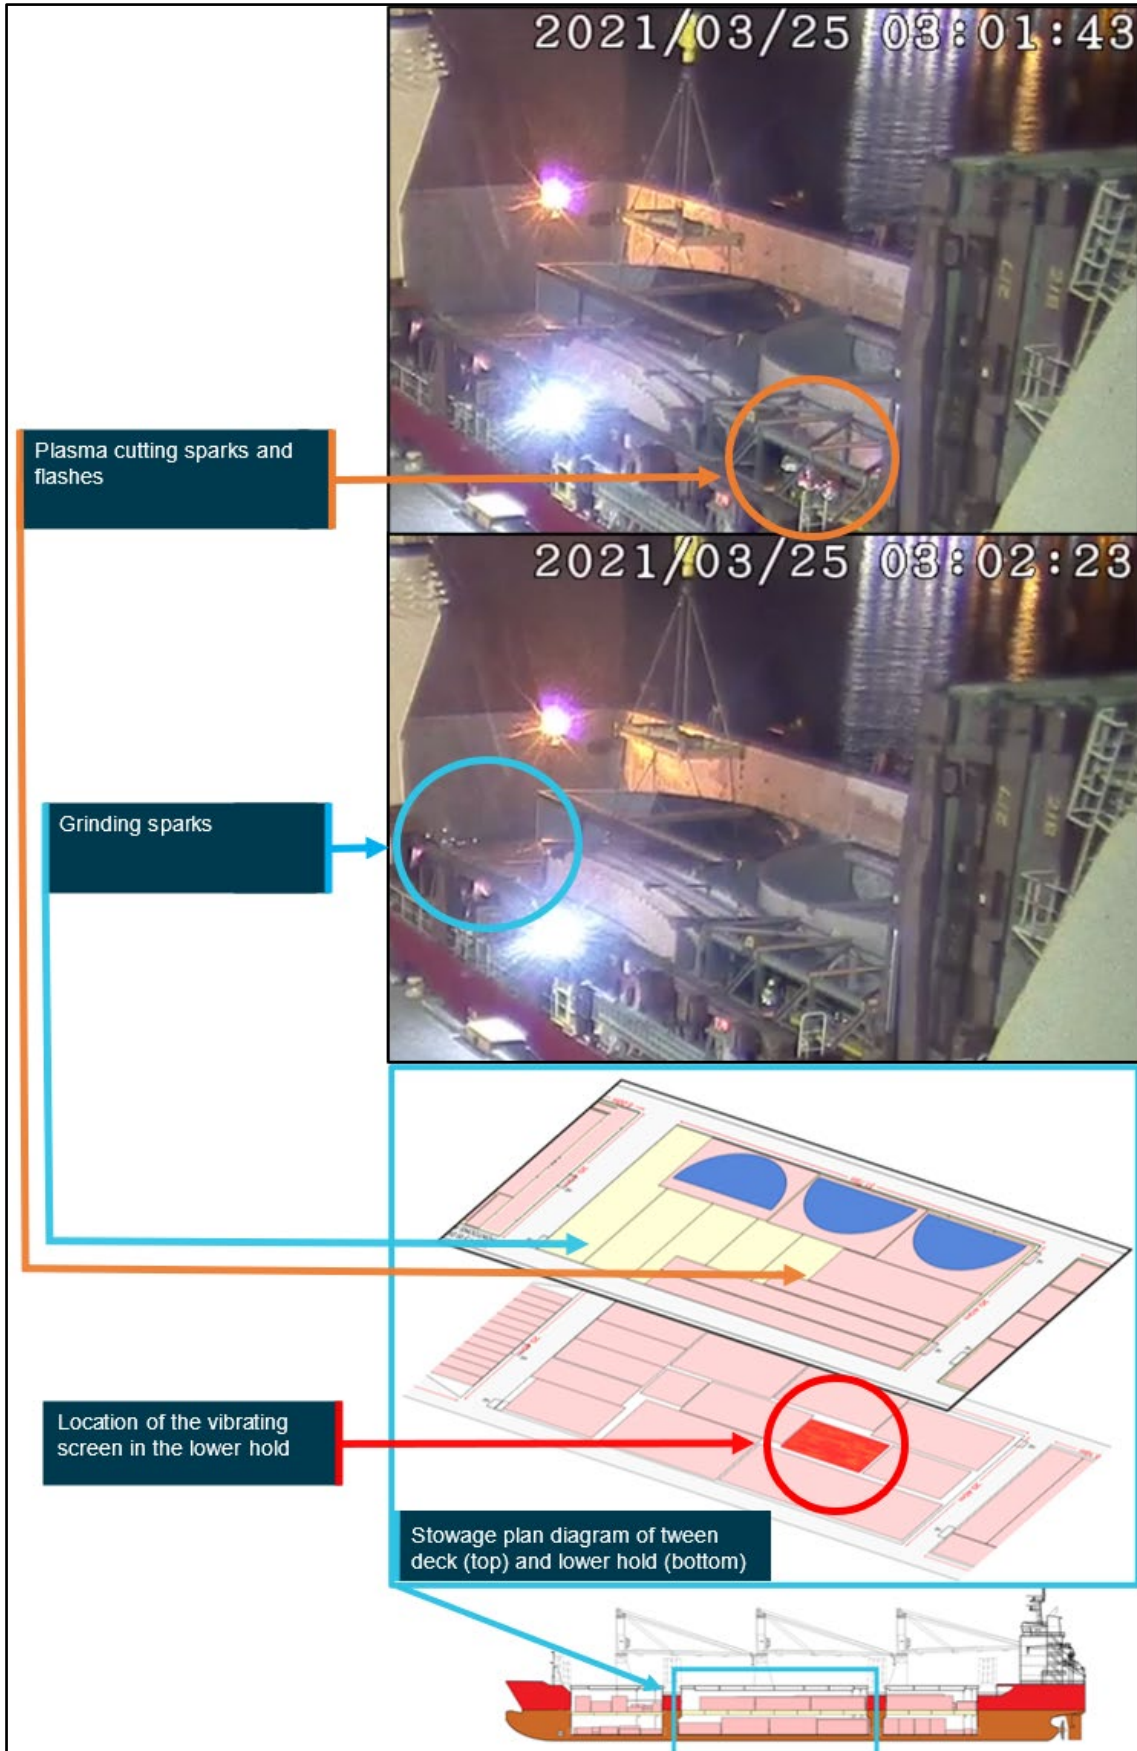
Figure 3: CCTV images of the hot work with the locations indicated on the stowage plan

Meanwhile, the bosun continued using the plasma torch and had progressed to the aft part of the tween deck, located above the plastic-wrapped screen assemblies in the lower hold below. At that time, sparks from the plasma cutting were spreading across a broad area. A smaller quantity of sparks was also generated by the grinding work forward (Figure 3).

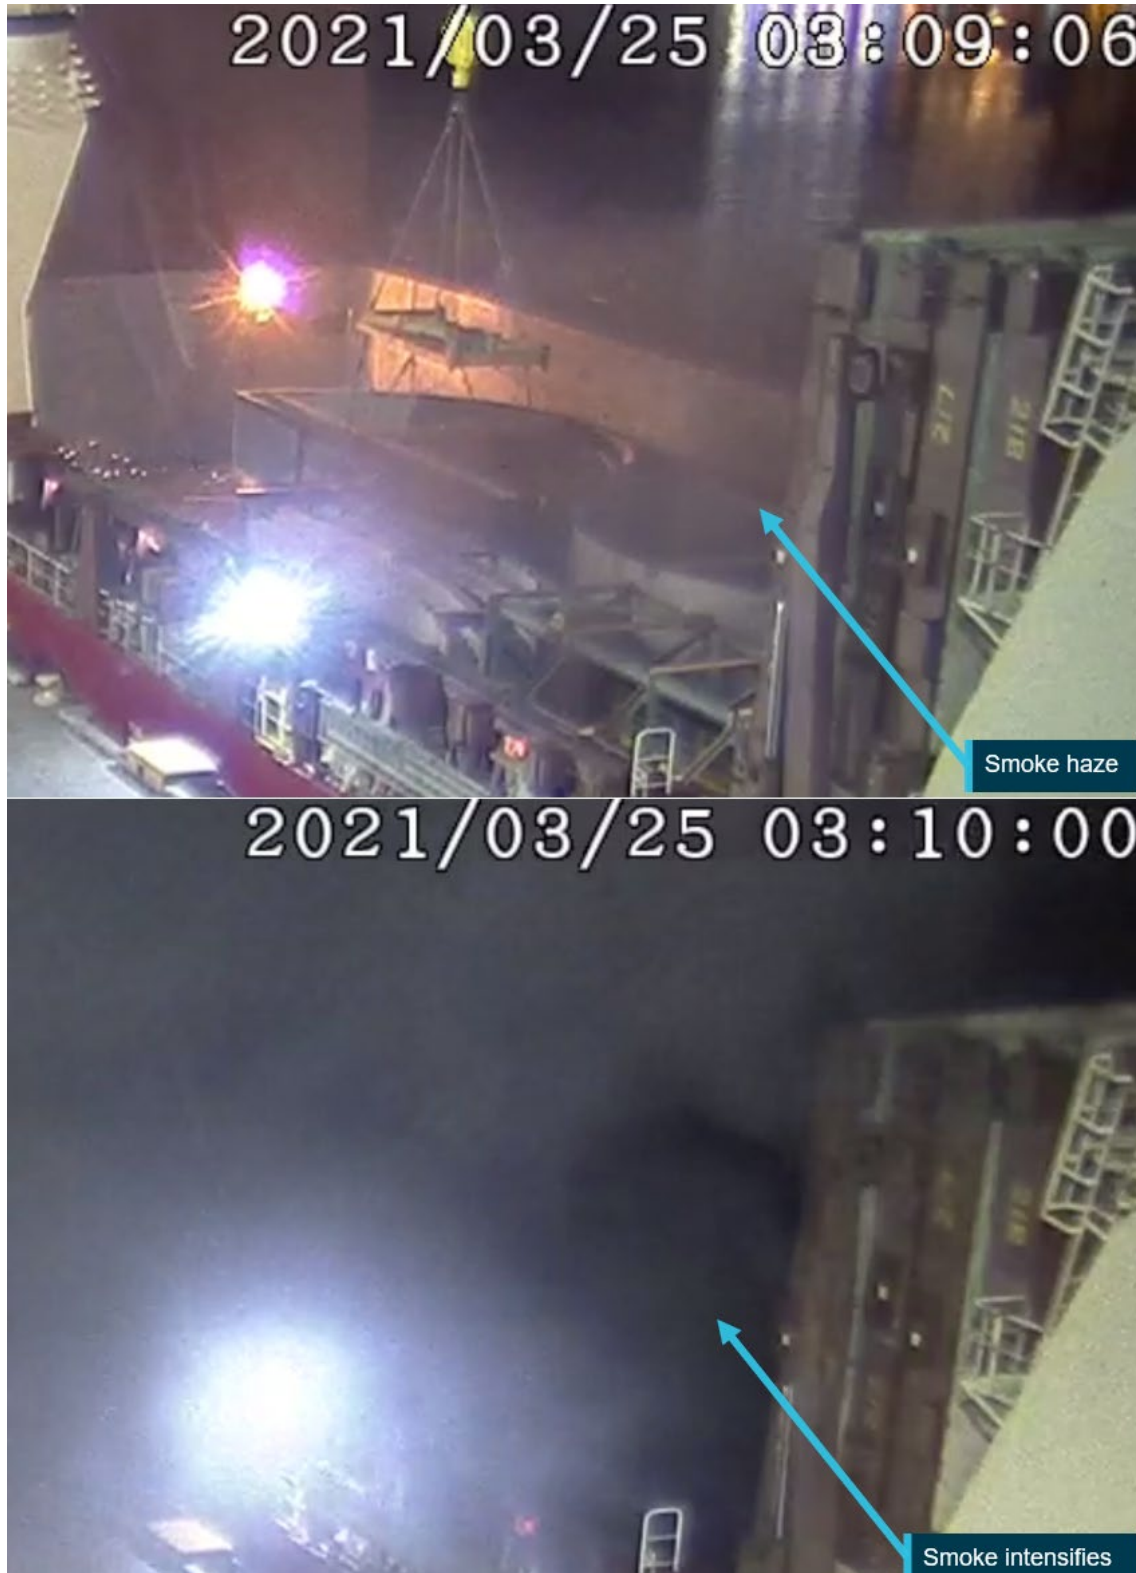
**Figure 4: Intensifying smoke from the lower hold (CCTV frames at 0309 and 0310)**

At 0309, the second mate on the tween deck saw smoke rising from the aft part of the lower hold. The smoke intensified quickly and began billowing over the cargo hold and the wharf (Figure 4). The stevedores also saw the smoke and quickly left the ship, leaving behind an item of cargo on the tween deck connected to the crane hook in preparation for discharge.

The second mate, bosun and OS immediately directed water towards the area where the smoke was rising using the available fire hoses. Shortly after, they also saw flames coming through gaps in the tween deck.

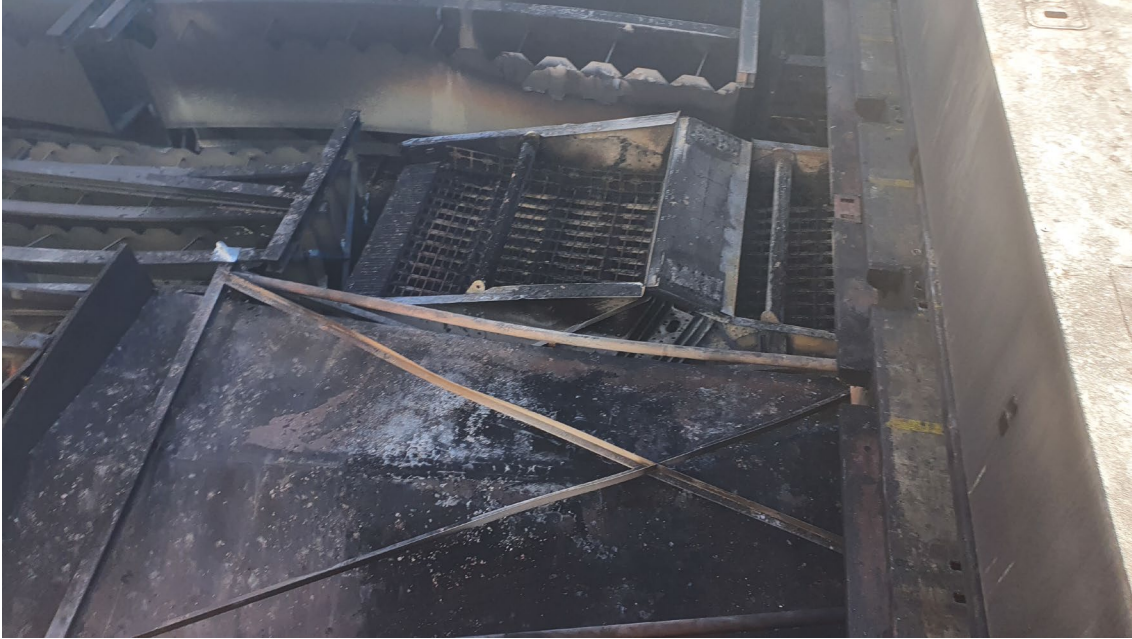
**Figure 5: Burnt remains of the vibrating screen assembly**

At 0804 on 28 March, DFES firefighters declared the fire extinguished. Post-fire inspections identified that the fire started on one of the linear vibrating screen assemblies stowed in the lower hold, directly below where the bosun was last seen plasma cutting before the smoke and flames were sighted (Figure 5).

The fire destroyed the vibrating screens. Photos taken after the fire showed that the intense heat from the blaze had left scorch marks on surrounding areas in cargo hold number two and on several items of cargo on the tween deck above the fire. The firefighting efforts had resulted in the accumulation of 600 cubic metres of water in the bottom of the hold. This wastewater was transferred into the ship's water ballast tanks and later disposed of in compliance with marine pollution prevention regulations.

Shortly before smoke was observed rising from the lower hold, the bosun had been cutting fastenings with a plasma torch in an area on the tween deck which was located above a vibrating screen assembly stowed in the lower hold. The screen was later identified by firefighters from the Western Australia Department of Fire and Emergency Services as the origin of the fire.
