# Fire on board *BBC Rhonetal*

Port Hedland, Western Australia on 25 March 2021

## **ATSB Transport Safety Report**

MO-2021-002

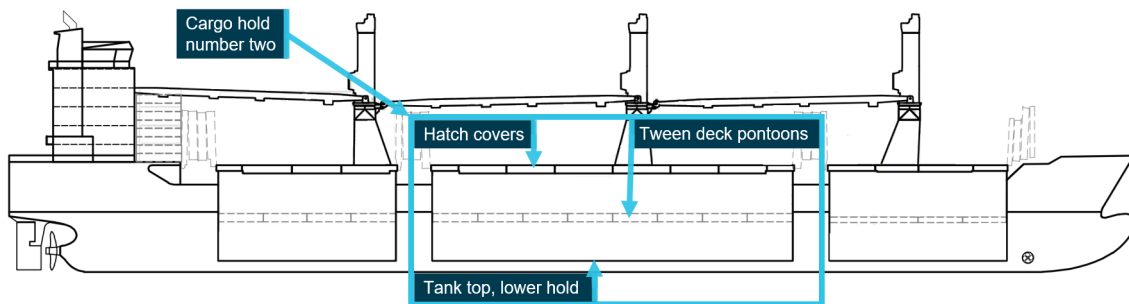
**Figure 1: Profile view of *BBC Rhonetal***

At about 2358 on 24 March, the bosun and an OS, along with the second mate as supervisor, arrived on deck to assume the cargo watch. Shortly after, they started preparations as planned to cut the sea fastenings. In anticipation of this hot work, several crew members on the earlier watch had opened the hatch covers to number two cargo hold and prepared firefighting equipment on the tween deck in the hold (Figure 1).

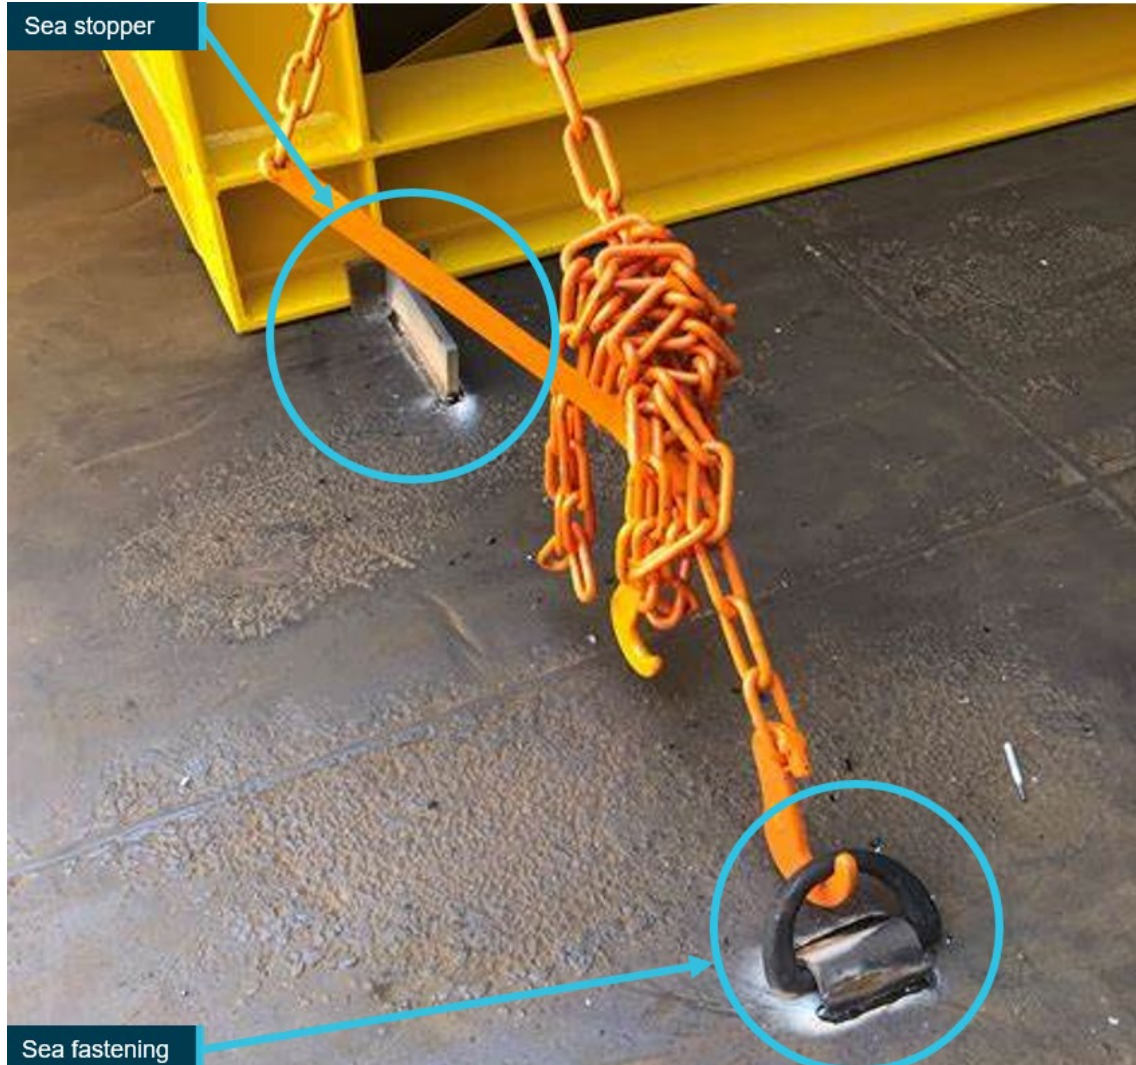
**Figure 6: Example of project cargo securing**

(often referred to as sea stoppers) to the deck, and directly against items of cargo, to prevent movement across the deck while at sea (Figure 6).

Since the fastenings and stoppers were welded to the deck, hot work techniques including cutting and gouging were required to remove them whenever the cargo was discharged. As a result of this type of cargo securing arrangement, hot work operations were much more frequent on this type of multi-purpose general cargo ship than on many other types of cargo ships.
